# SZIGETKÖZ

## Reconnecting a Danube Floodplain

The story of a large-scale floodplain rehabilitation in Hungary

Danube Region Water Lighthouse Action | Grant Agreement No. 101094070

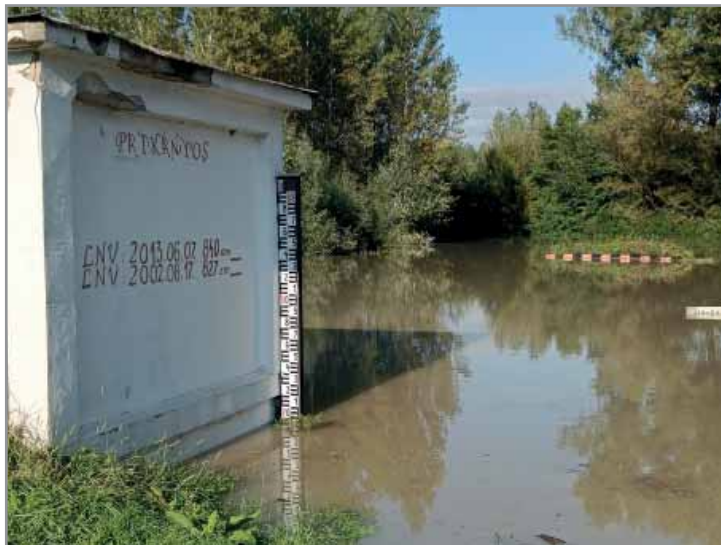
Figure 10: Flood event on the Danube in Szigetköz, in September 2024

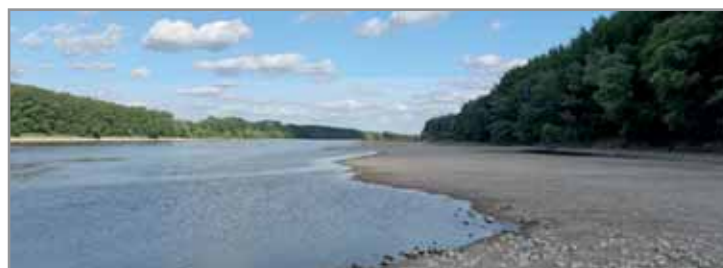
Figure 12: Old Danube in Szigetköz during low flow conditions

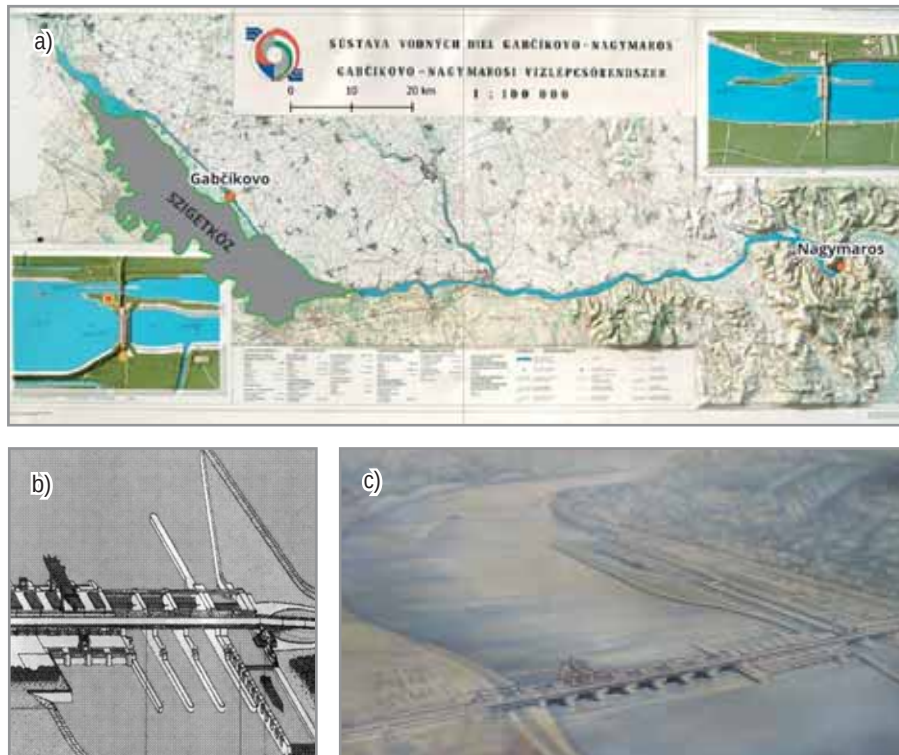
Figure 13: Design Concepts and Plans: Photograph of a 3-dimensional raised relief map of the impacted area of the Gabčíkovo–Nagymaros Barrage Project (a). Axonometric computer drawing of Gabčíkovo HPP (b). Artistic representation of the Nagymaros Barrage (c)

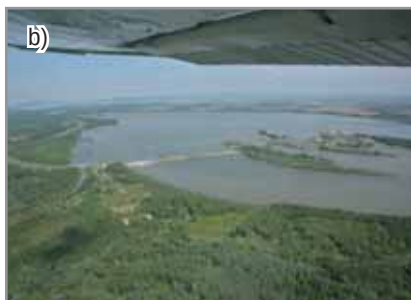
Figure 14: a) Layout of Variant "C" and its principal structures. b) The Čunovo Barrage was built to take the place c) of the Dunakiliti Barrage in diverting water from the Old Danube towards d) the Gabčíkovo Hydropower Plant

During the 1980s, environmental concerns and political opposition grew in Hungary. Work at Nagymaros was suspended in 1989. Czechoslovakia then developed Variant C (#10), an alternative configuration that allowed the upstream part of the project to operate without the Hungarian Dunakiliti and Nagymaros structures (International Court of Justice, 1997).

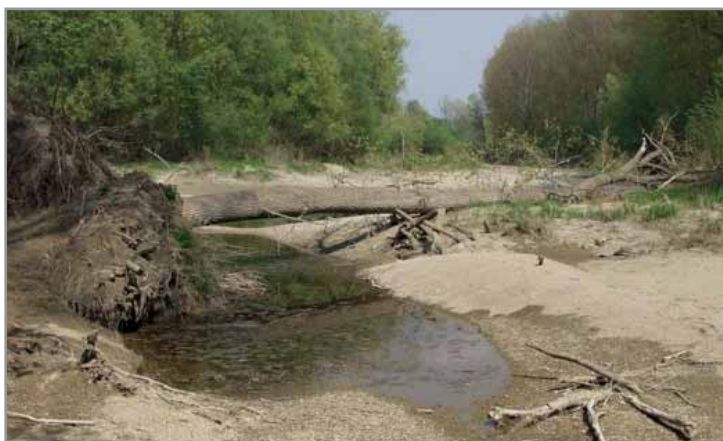
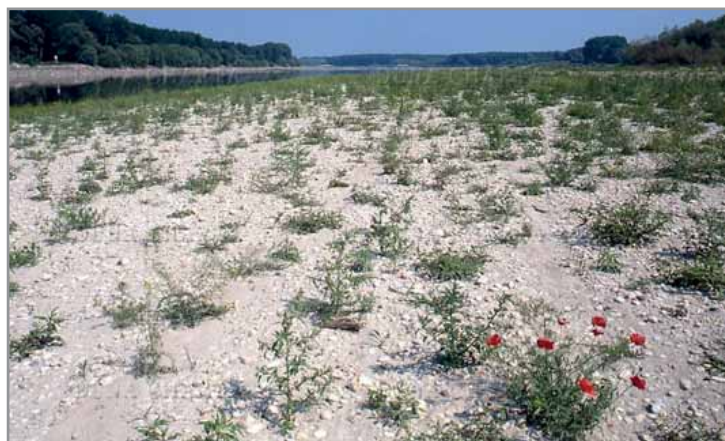
Figure 16: Dry active floodplain branches following the diversion of the Danube—source: Fertő–Hanság National Park Directorate

The most urgent damage was visible in the dry branches, where aquatic habitats had been severely reduced or lost in some reaches. The first interventions (#13) concentrated on returning water to these channels. The emergency response became the starting point for the larger replenishment system (#20), (#34) (KvVM, 1996; Dunai, 1995).

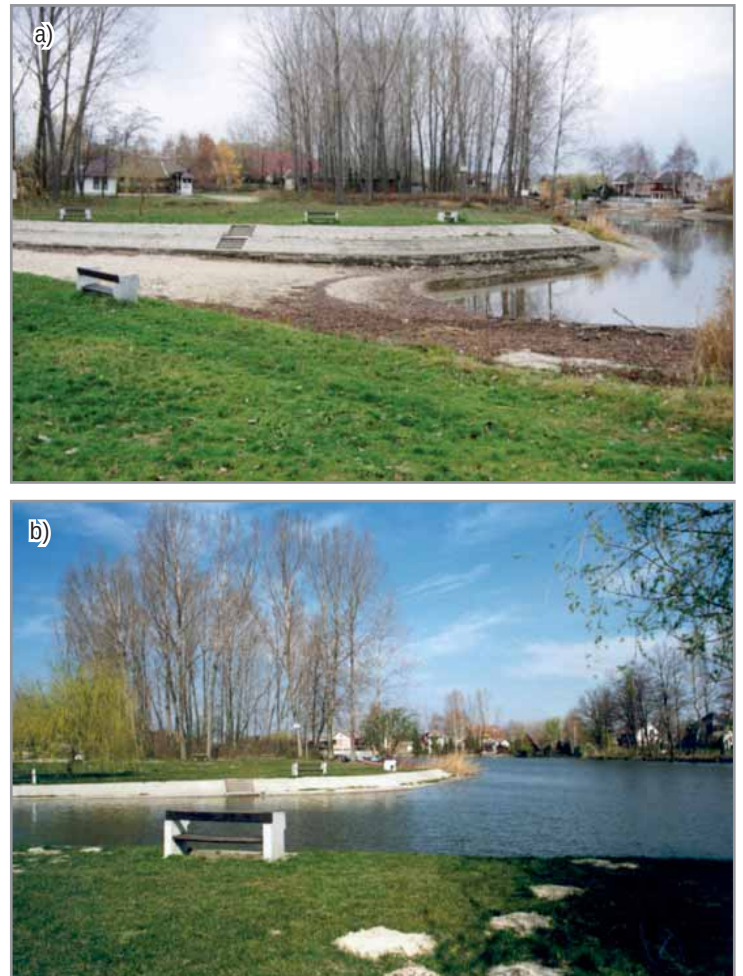
Figure 17: Dry conditions in the Zátonyi-Danube near Doborgazsziget in November 1992 (a) and after the return of water in May 1993 (b)

The plan was approved as an emergency measure. A side spillway and a short feeder channel allowed 2-5 cubic meters per second to enter the Zátonyi-Danube—an upper historical-floodplain branch—and nearby channels. About six months after the diversion, water had returned to sections of the Upper Szigetköz historical floodplain (Dunai, 1995).

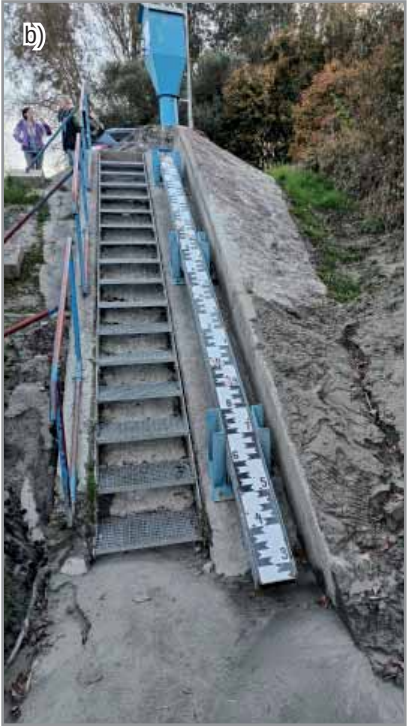
Figure 21: Relationship between Danube discharge (Q) at Bratislava (Dévény) and water level (H) at Dunaremete during 1950–1959 and 1989–1992 period (a) Dunaremete gauge (b)

Because the relationship between Danube discharge and water level had changed, the same Danube discharge no longer produced the same water level at Dunaremete as it had during the reference period. The river and floodplain had physically changed. Rehabilitation had to combine an appropriate water supply with structures capable of raising, retaining, and distributing water through the branch network (Janák et al., 2014).

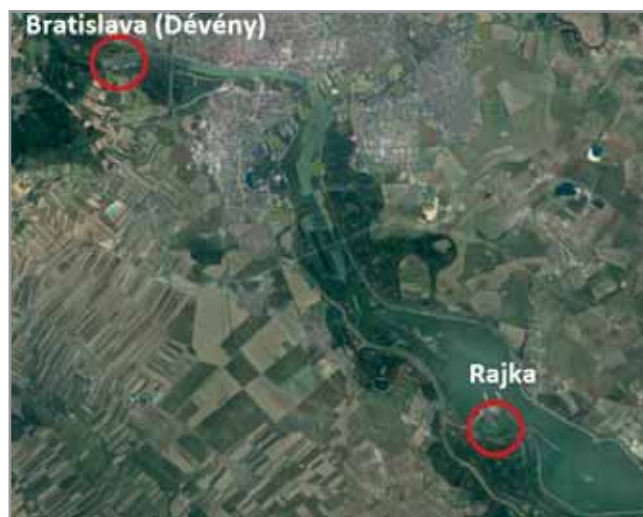
Figure 24: Relationship between Danube discharge at Bratislava (Dévény) and the flow entering the Szigetköz reach at Rajka (ÉDUVIZIG, 2001). More water was made available during the biologically active summer period, while actual releases continued to respond to changing Danube discharge at Bratislava (Dévény)

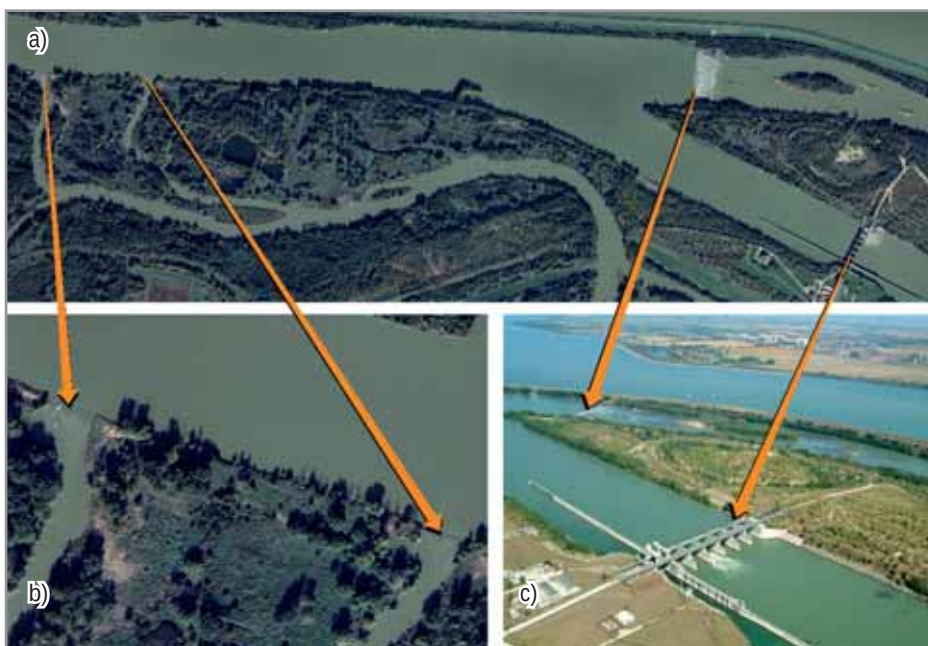
Figure 25: a) Dynamic control of the active floodplain; b) overflow weirs to supply the active floodplain, c) submerged weir, and Dunakiliti Barrage

The Mosoni-Danube receives water through a separate supply channel and toe-drain system from Čunovo (#22). Together, these three parts of the system allow water to be distributed according to the different needs of the active floodplain, the historical floodplain, and the Mosoni-Danube.

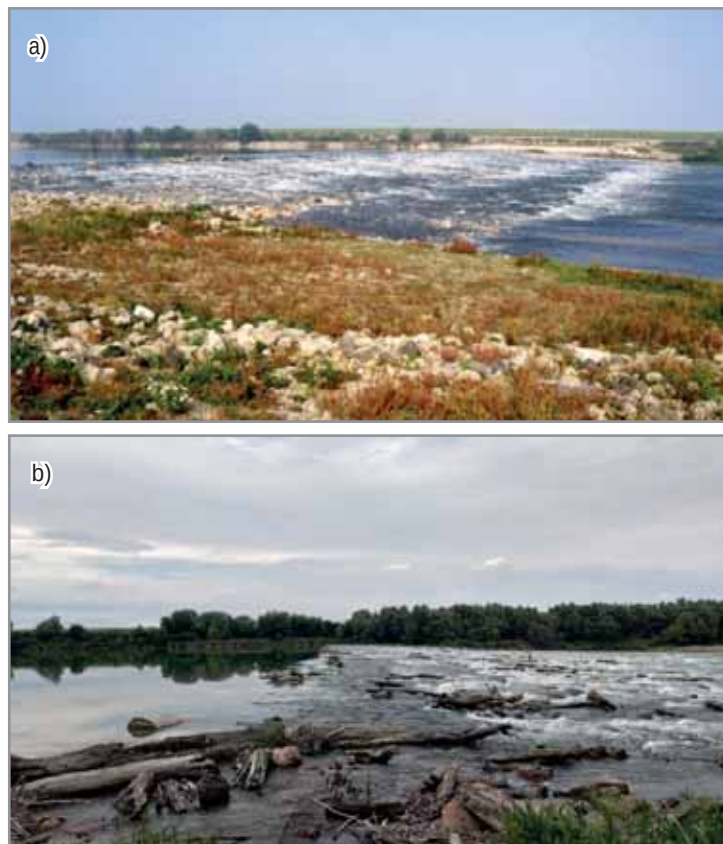
Figure 26: The submerged weir: a) after construction and b) in 2025.

The Dunakiliti submerged weir raises the water level in the Old Danube by about four meters relative to the local riverbed, creating the conditions needed for water to enter the active floodplain branches by gravity. Built mainly from stone, gabions, and gravel rather than conventional reinforced concrete, the structure creates a backwater upstream without forming a large reservoir (Dunai, 1995).

tween the floodplain branches and the Old Danube (#32). The long, gentle downstream slope of the submerged weir also dissipates energy and limits erosion, while its coarse surface can permit fish movement under suitable flow conditions (Kertész, 2017; Jakus et al., 2024).

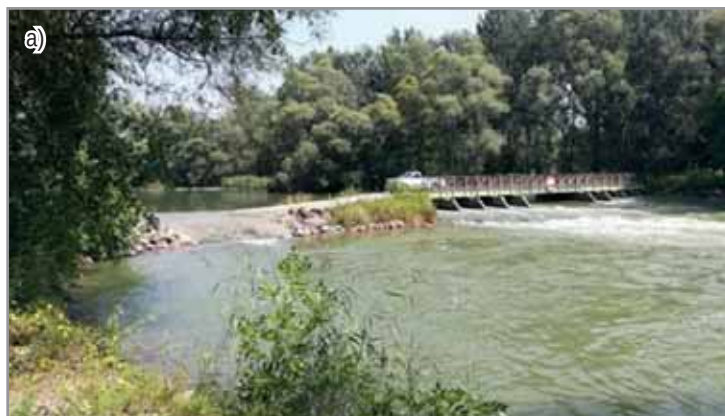
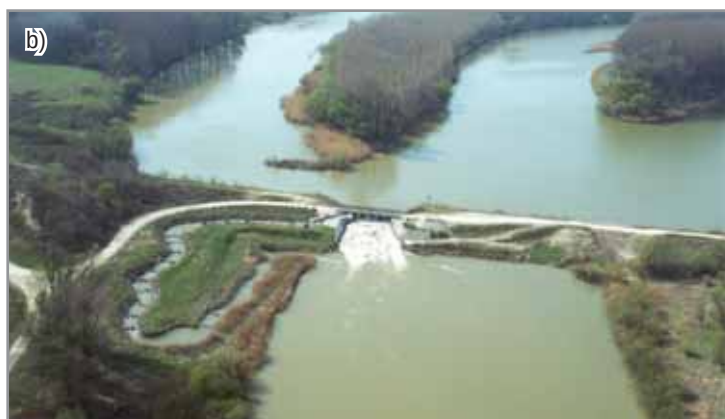
Figure 27: Examples of complex hydraulic structures used to distribute and retain water within the active floodplain: a) “Szent Kristóf” Bridge and water level control structure; b) “Denkpál” branch-end closure and fish passage

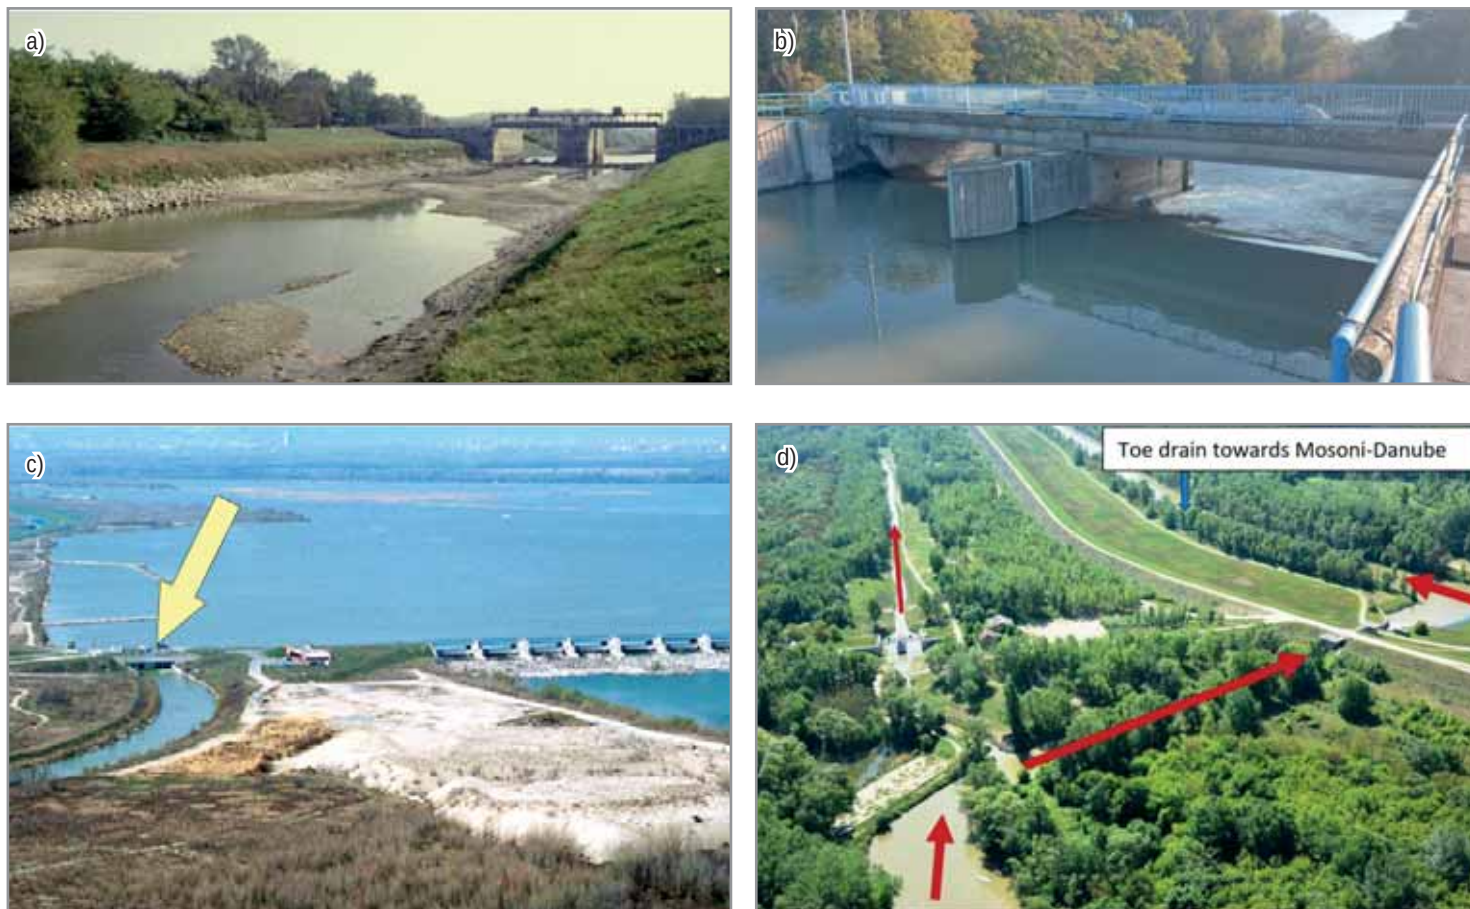
Figure 28: (a) Rajka Sluice Gate in 1991; (b) Mosonmagyaróvár Barrage in 2025; (c) Mosoni-Danube supply channel at the Čunovo reservoir; and (d) flow in the supply channel and toe-drain system near the Rajka Sluice Gate.

After the 1992 diversion, water released from the Čunovo reservoir was conveyed toward the Mosoni-Danube through the supply channel and toe-drain system. The 1995 agreement (#19) increased the available discharge and allowed water to be divided between the Mosoni-Danube, the Zátónyi-Danube route supplying the historical floodplain (#13), and, under certain conditions, the active floodplain (Agreement, 1995).

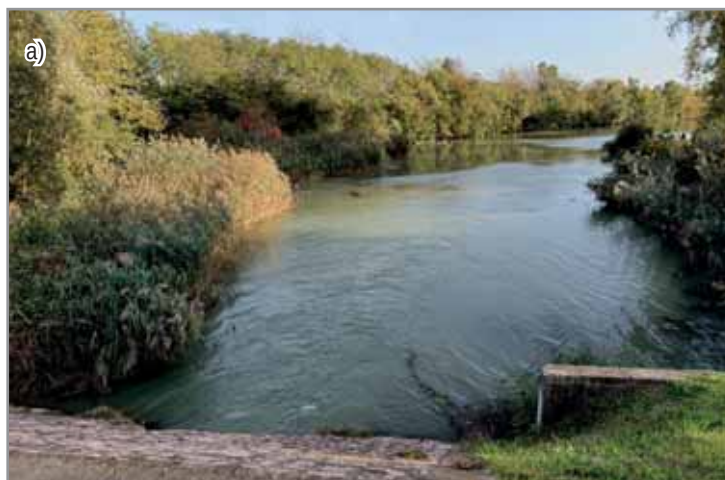
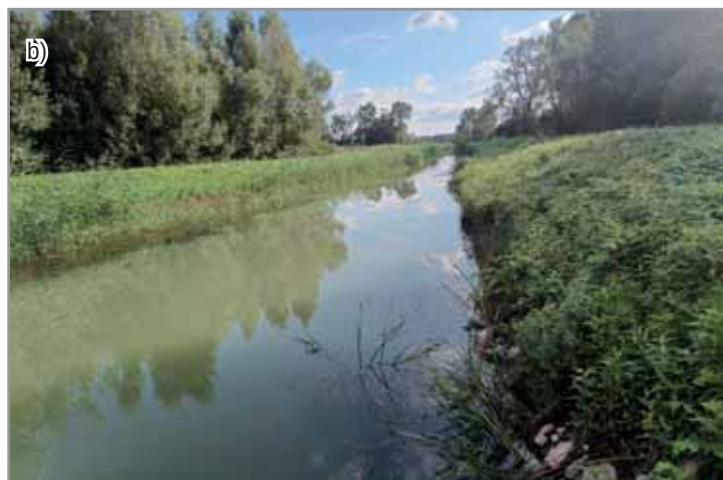
Figure 29: A channel used for both water replenishment and drainage in the historical floodplain in Upper Szigetköz (a) and Lower Szigetköz (b)

Using the same network for both replenishment and drainage created a new challenge. Water needs to be retained to support wetlands, fisheries, wet meadows, and other water-dependent landscape functions. During periods of intense rainfall, or when floods cause seepage beneath the levees and high groundwater levels, excess water must instead be drained to protect agricultural land and settlements.

Adjustable structures built during different phases of rehabilitation (#32) allow the direction and purpose of water management to change with conditions. Water can be supplied and retained in suitable low-lying areas when it is needed, while the drainage function remains available when conditions become too wet. The historical floodplain network operates in two directions: it can bring water into the landscape and, when necessary, carry excess water away (Dunai, 1995; Tatai and Pap, 2023). The replenishment system did not become fully developed in a single step. As structures were introduced and operation expanded, their performance was tested, monitored (#24), and adjusted under real river conditions (#25).

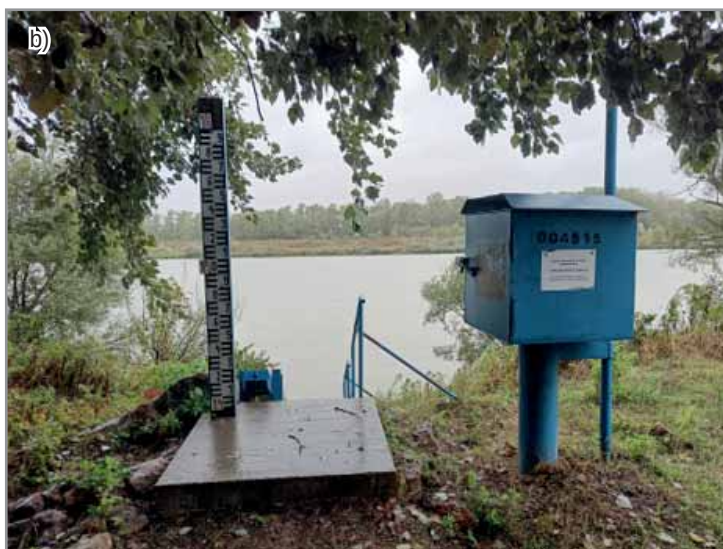
Figure 30: Locations of surface-water level gauging stations in Szigetköz. a) Gauging stations are monitoring points where river or channel water levels are measured regularly or continuously to track changes over time (Szűcs, 2018 ); b) Old Danube gauge at Doborgaz

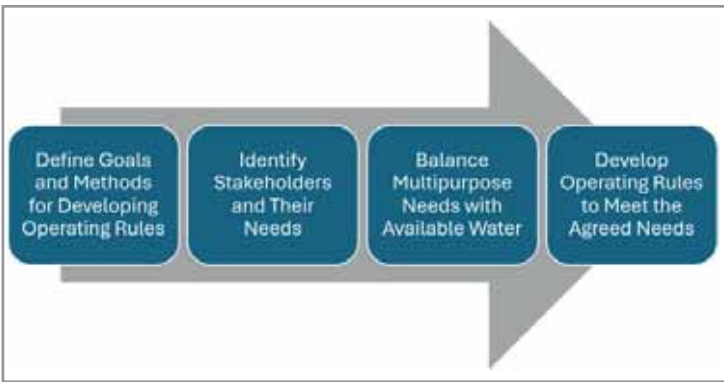
Figure 32: Developing the permanent operating rules: stakeholders identified their needs and balanced them against the available water and the system's technical limits before the rules were finalized

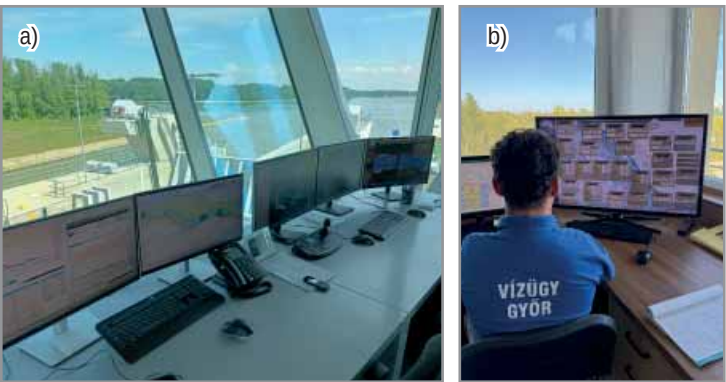
Figure 33: a) Mosoni-Danube outflow structure operation control; b) daily water-level control at Dunakiliti

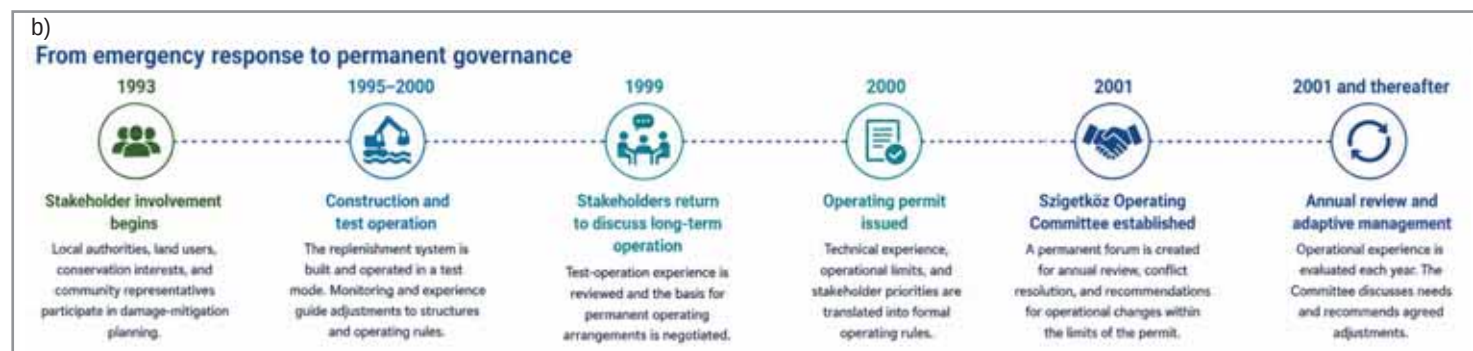
Figure 34: a) Meeting of the Szigetköz Operating Committee in 2025; b) Process leading to the establishment of the Szigetköz Operating Committee

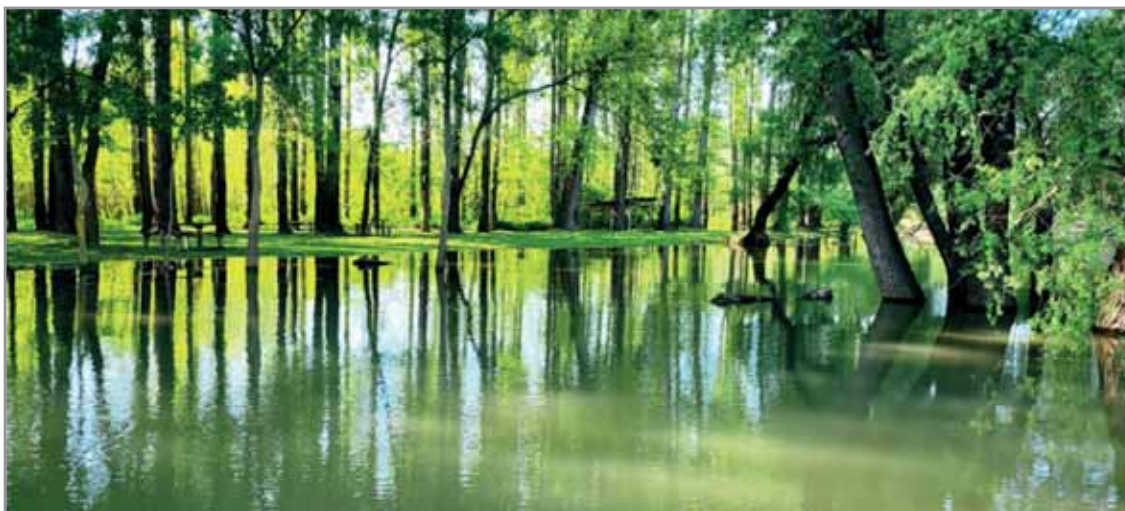
Figure 35: Controlled floodplain inundation in the Szigetköz active floodplain

Routine replenishment (#21) cannot reproduce the temporary rise in water levels that once accompanied spring floods (#16). To restore part of this seasonal dynamic, controlled floodplain inundation has been carried out in selected years since 2004. During April and May, when Danube flow forecasts, water temperatures, and operating conditions are suitable, releases to the Old Danube can be increased and approximately 200–250 cubic meters per second can be directed into the active floodplain for about two weeks (Kertész, 2017; Tatai and Pap, 2023).

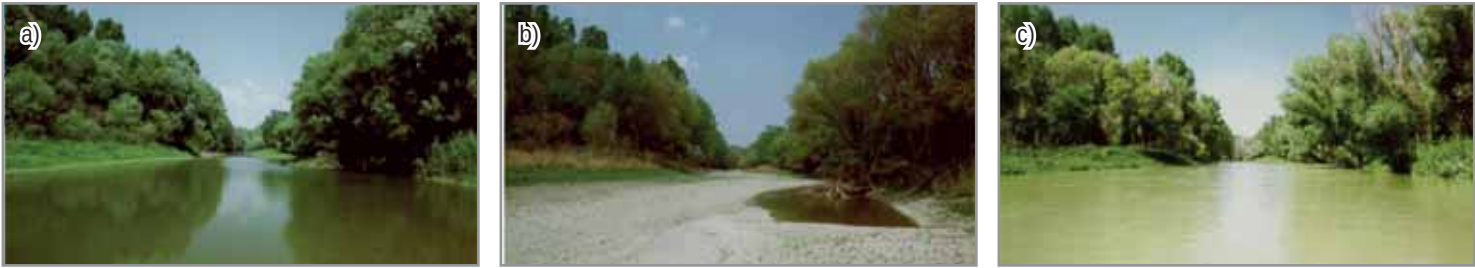
Figure 36: Surface water in an active floodplain branch a) before the diversion (1988); b) after the diversion (1993); c) following water replenishment (1995)

Surface-water conditions improved visibly in large parts of the active and historical floodplains. Previously dry channels (#11) refilled, and water levels stabilized in many directly supplied branches and water bodies. The greatest improvements generally occurred close to channels receiving replenishment water, while the effect weakened farther from the supplied network (Jakus et al., 2024).

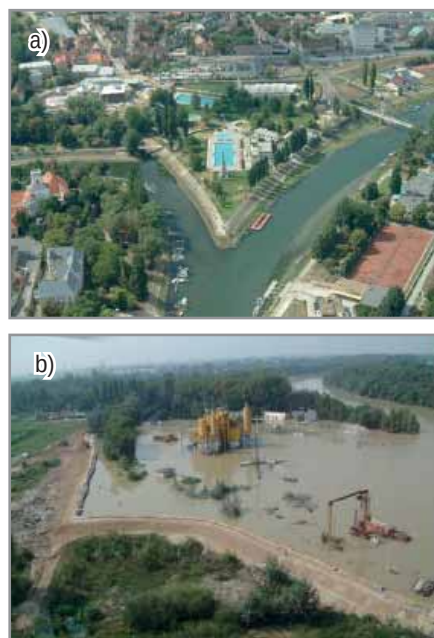
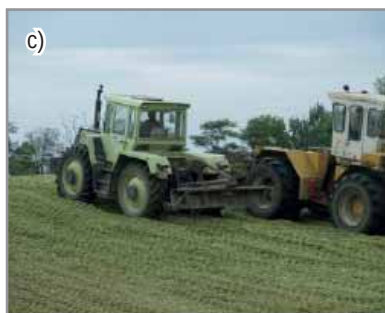
Figure 38: Main factors influencing water quality in the Mosoni-Danube: a) incoming Danube water and tributary inflows; b) diffuse pollution and accidental events; c) floods and local flow conditions; and d) wastewater discharges. Together, these factors influence water quality in the river and connected branch systems (Pannonhalmi, 2005)

Consequently, water entering the replenishment system had better chemical quality than during the 1960s–1980s. Conditions within the network, however, were also influenced by tributary inflows, local pollution sources, floods, and local flow conditions. Slow flow, long residence time, fine-sediment accumulation, and high biological productivity could promote algal growth and large daily variations in dissolved oxygen (Pannonhalmi, 2007; Ördög and Koltai, 2008).

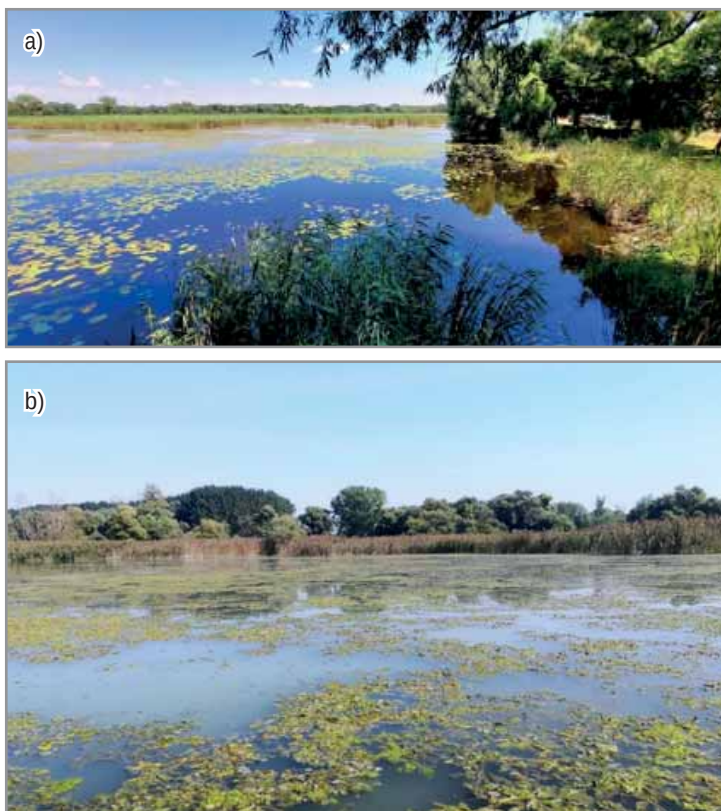
Figure 39: a) Lipót Oxbow Lake (Lipóti-morotva-tó) in the historical floodplain; b) Öntési Lake, representing a slow-flowing or standing-water habitat within the active floodplain mosaic

Recovery, however, differed among habitats. Flowing channels, slow-flowing branches, oxbows, and temporarily connected water bodies responded differently, and ecological conditions remained strongly dependent on local water exchange and connectivity. Some poorly connected or slow-flowing waters were more vulnerable to algal growth and other signs of eutrophication (Pannonhalmi, 2006, 2007; Ördög and Koltai, 2008).

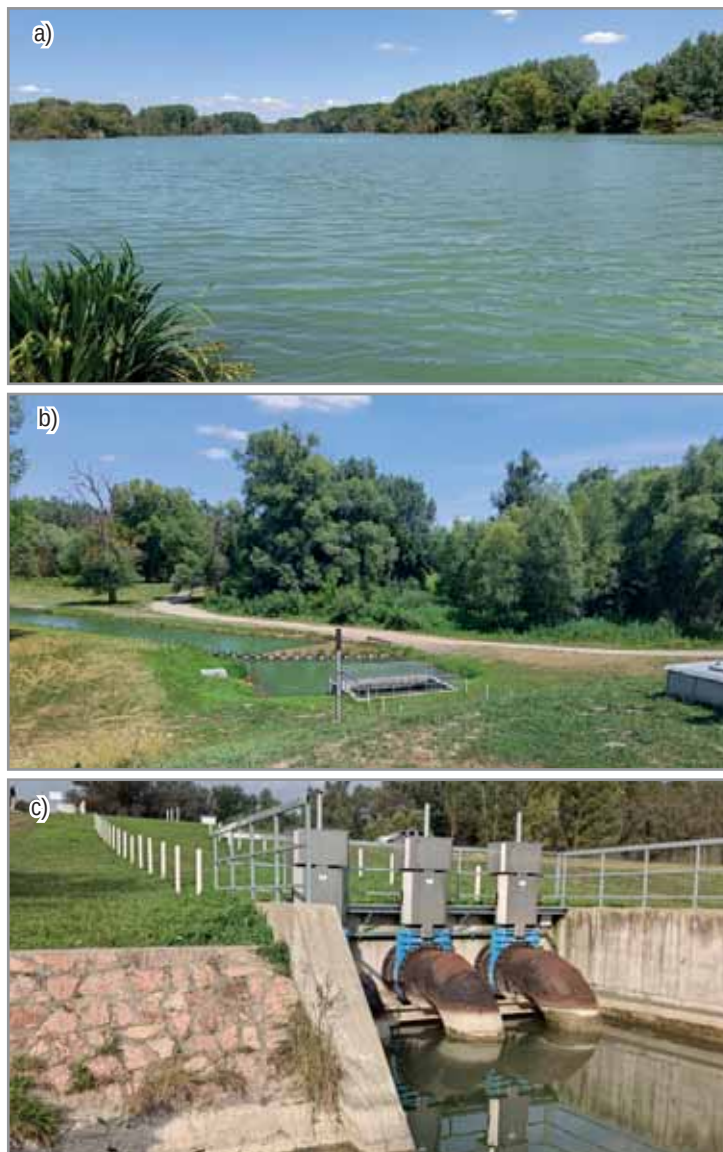
Figure 40: (a) Replenished river branch in Ásványráró; (b,c) Béka-ér Siphon in Ásványráró supplying water from the (b) active floodplain to the (c) historical floodplain

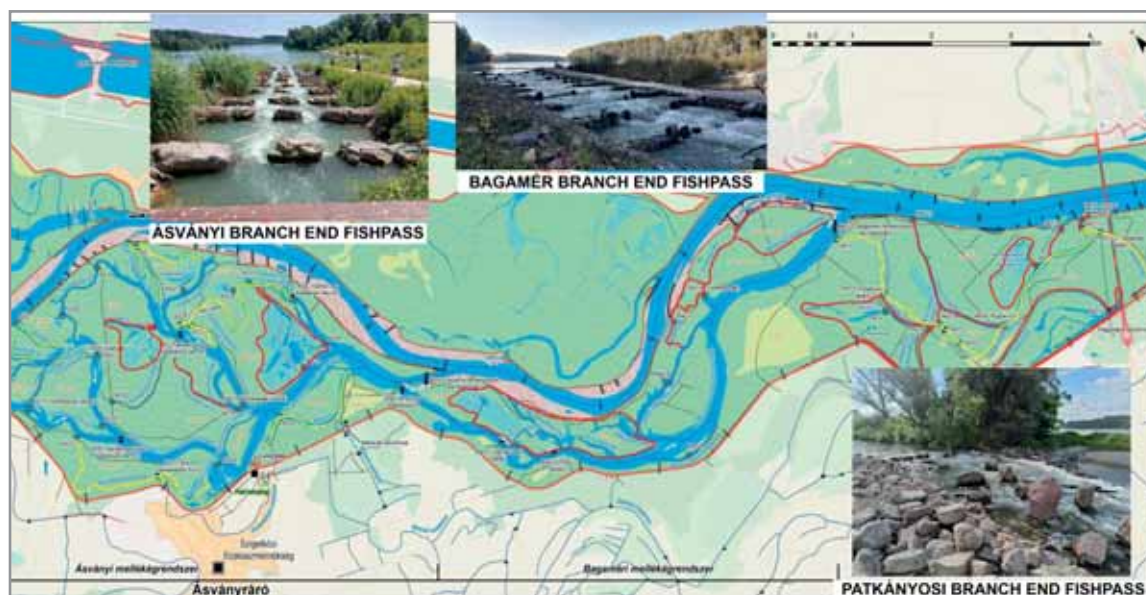
Figure 41: Extension of water replenishment through the lower Ásványi, Bagaméri, and Patkányosi branch systems with photos of fish passages. Base map: ÉDUVIZIG

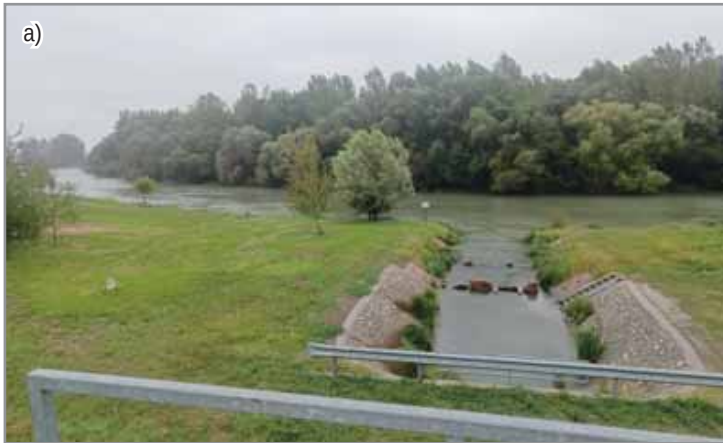
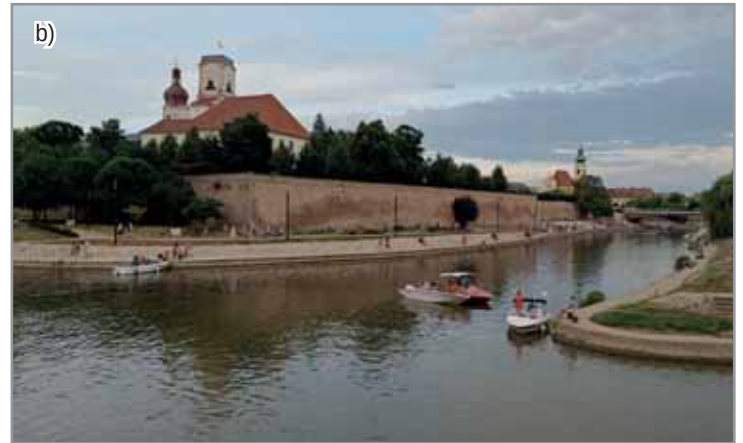
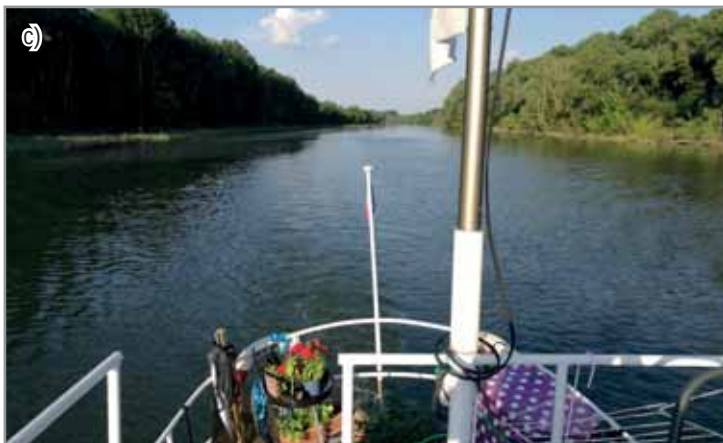
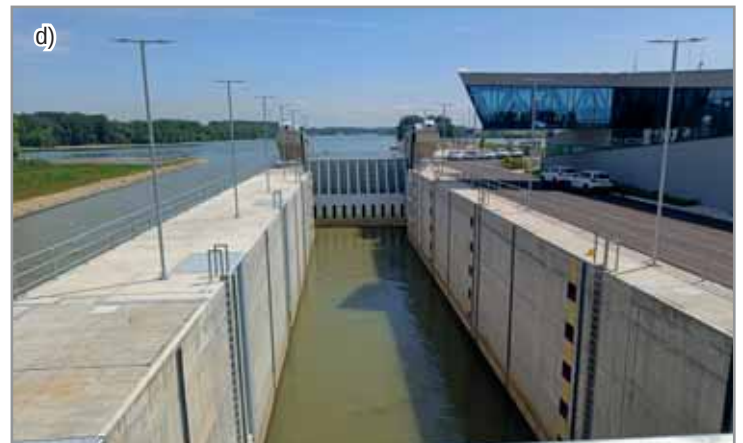
Figure 42: Rehabilitation of the Mosoni-Danube: a) Historical floodplain branch connection to the Mosoni-Danube upstream of Győr; b) River landscape in Győr; c) small boat downstream from Győr; d) the Mosoni-Danube Outflow Structure

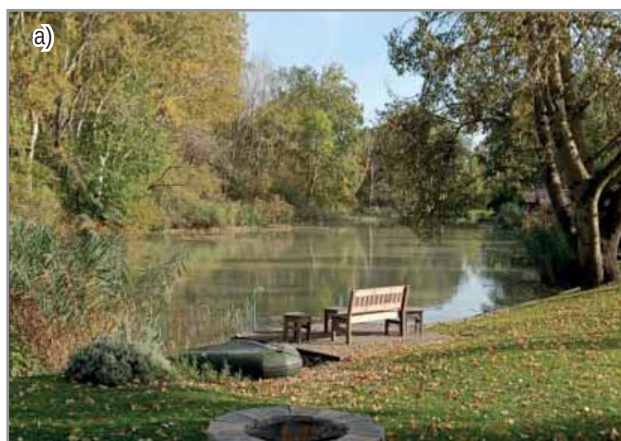
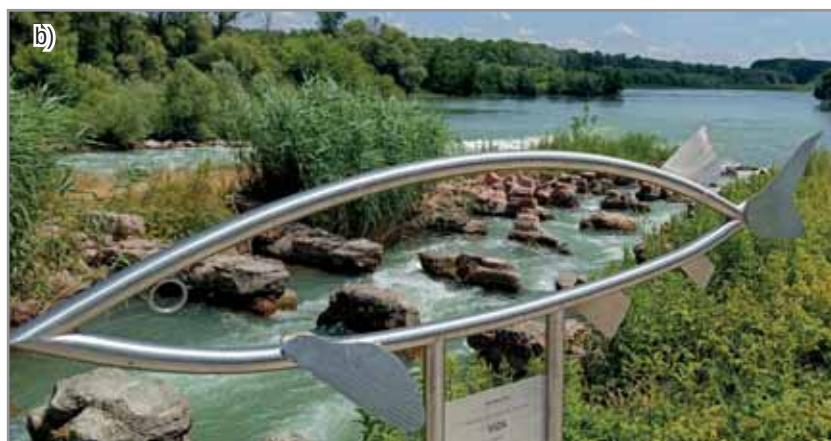
Figure 43: Rehabilitation in Szigetköz: a) historical floodplain; b) fish passage between the active floodplain and the Old Danube (Ásványráró)
